NEPA Environmental Assessment  
Brenham Family Park  
Brenham, Washington County, Texas

Prepared for:  
City of Brenham  
Brenham, Texas

Prepared by:  
Wild Associates LLC

Wild Associates Project Number 21.01.016

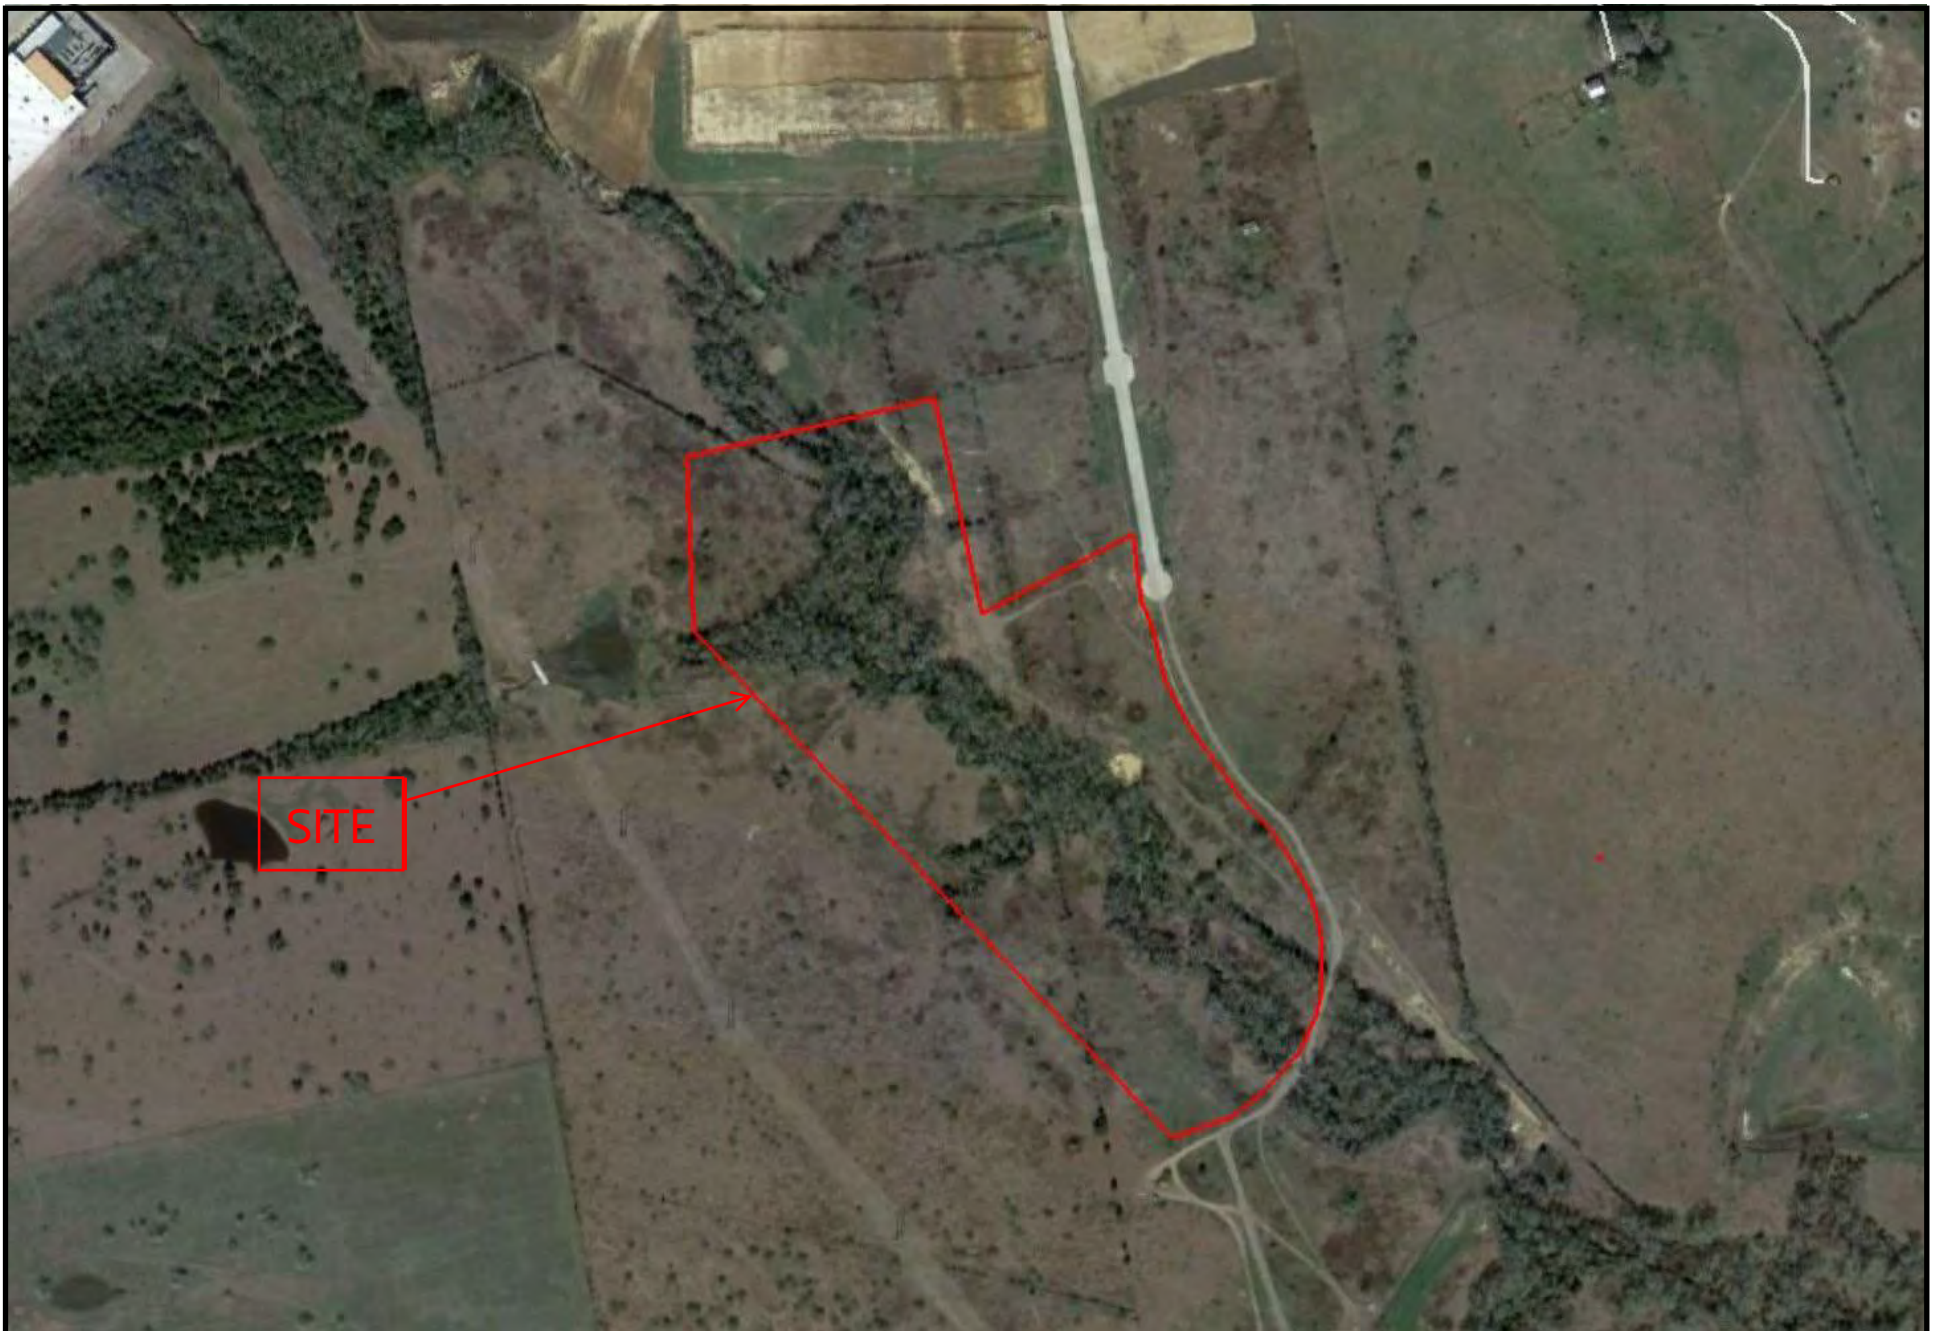
FIGURE 13  
2021 AERIAL PHOTOGRAPH  
Source: Google Earth

Portions of the Site and land adjacent to the Site are grasslands suitable for grazing of livestock, although no evidence of grazing was observed. No timber harvesting is occurring or appears to have occurred in the recent past. The Site is in a natural or naturalized state and unused for agricultural, silvicultural, or recreational purposes. See Figures 11 - 13 – Aerial Photographs.

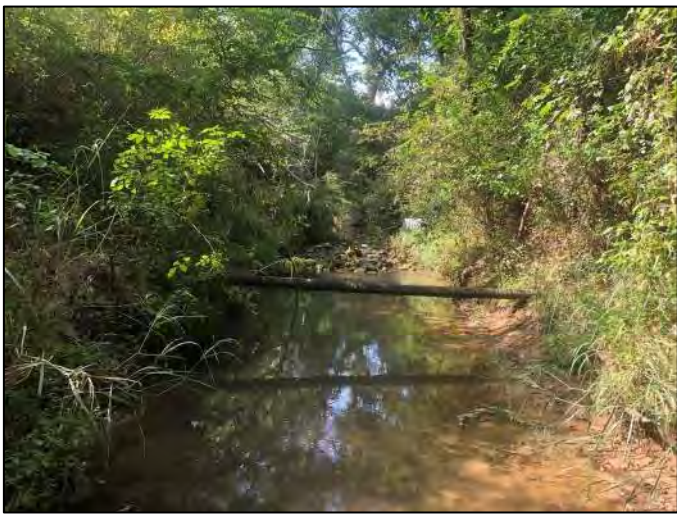
Photo 13: Upstream-facing of gas pipeline.

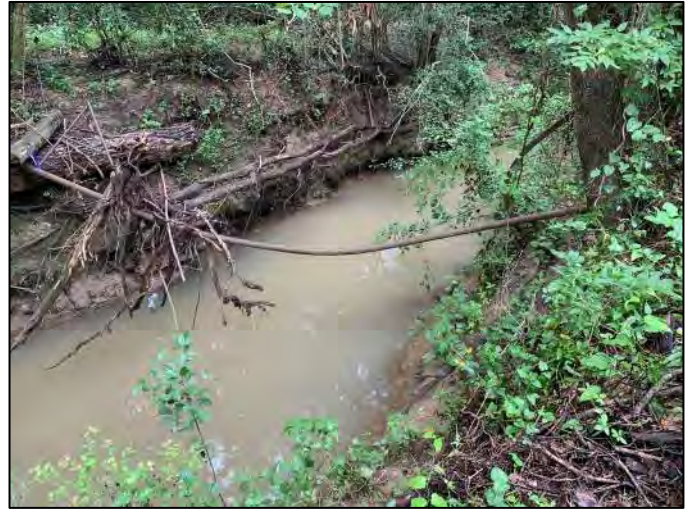
Photo 16: Upstream-facing view of remnants of a metal gate crossing the creek.

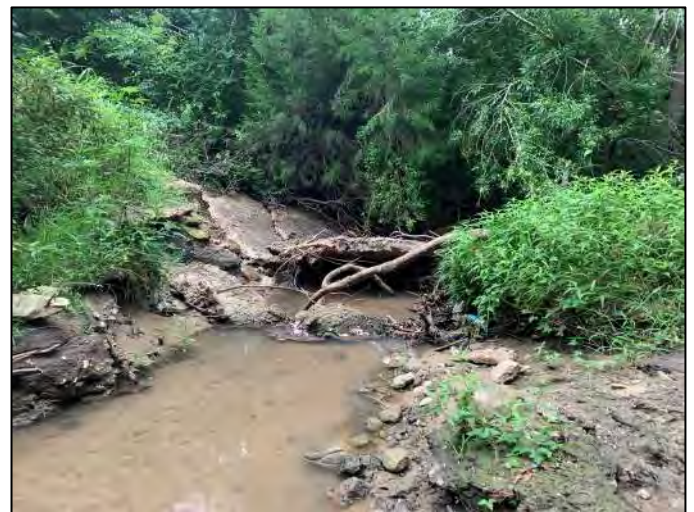
Photo 30: Downstream-facing view of creek and collapsed road.

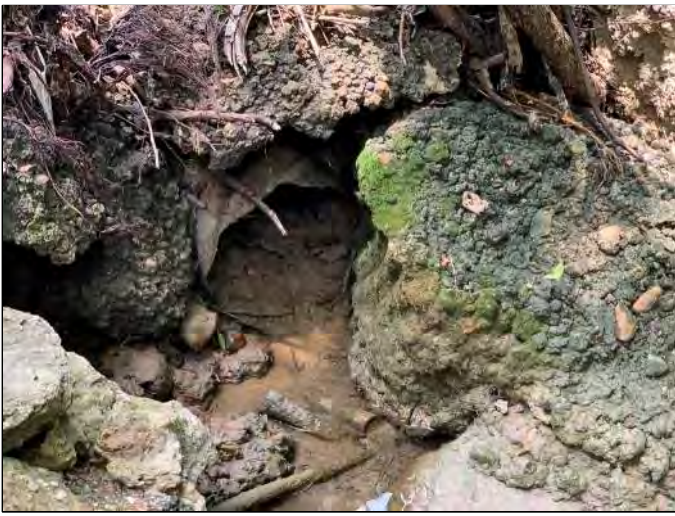
Photo 31: Crushed culvert under collapsed road.

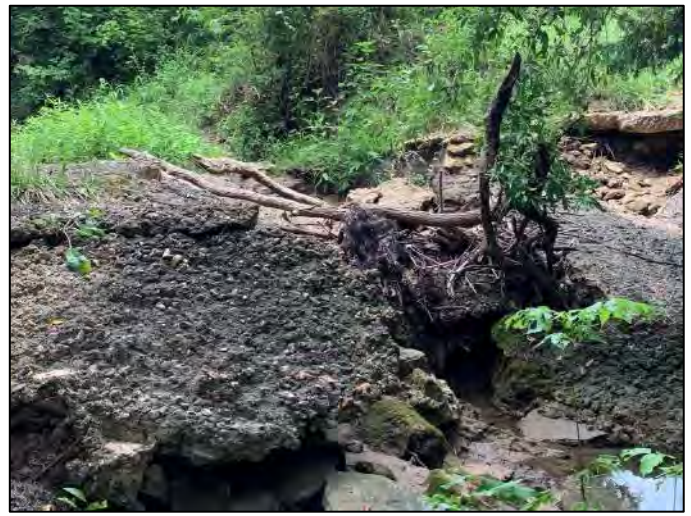
Photo 32: Collapsed road.

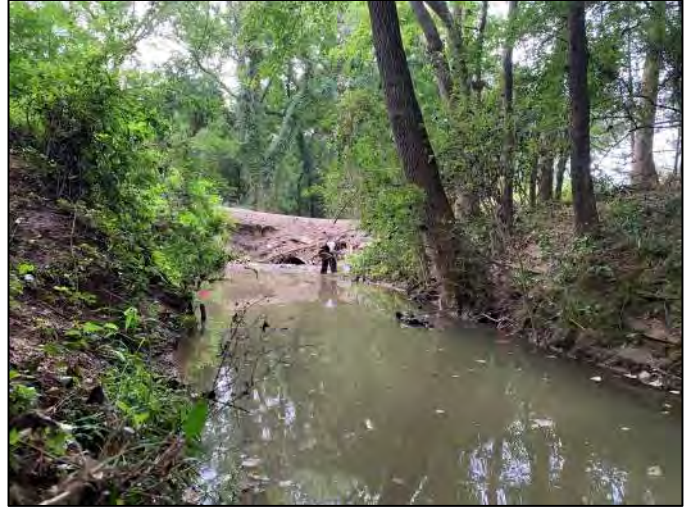
Photo 40: Downstream-facing view of southern dirt road and culvert.

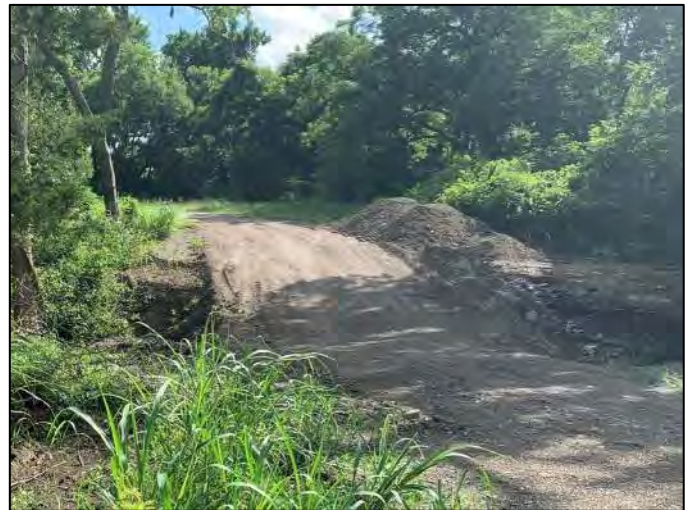
Photo 42: North-facing view of the dirt road crossing the culvert at the southern terminus of the Site.
