**NOTICE OF A MEETING  
THE BARNHILL CENTER ADVISORY BOARD MEETING  
MONDAY, OCTOBER 12, 2026, AT 4:00 PM  
MORRISS HALL, THE BARNHILL CENTER  
106 DOUGLAS STREET  
BRENHAM, TEXAS**

**6. Review and Discuss an Update from the Venue Preservation Committee Regarding The Barnhill Center Building Assessment and Urns**

This assessment is provided on a pro-bono basis to assist the Advisory Board for the Barnhill Center in developing a priority list for maintenance projects, including acute maintenance issues, preventative maintenance, and potential future improvements. The assessment is not a complete and exhaustive list as all spaces were not accessible nor were destructive methods used to evaluate concealed conditions. Items identified were visible during a walk through of the interior and exterior of the building. Development of a detailed maintenance plan or facility strategic plan is beyond the scope of our work.

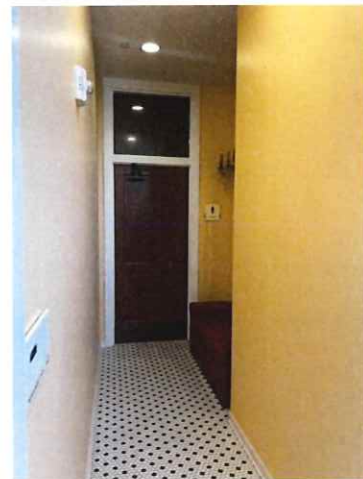
Generally, the building meets the accessibility requirements as defined in the Texas Accessibility Standards. One exception is the signage at the Ballroom restrooms which exceeds to height standard of a maximum of 60" to the baseline of the highest tactile character. Other signage and working components observed appear to meet the code requirements.

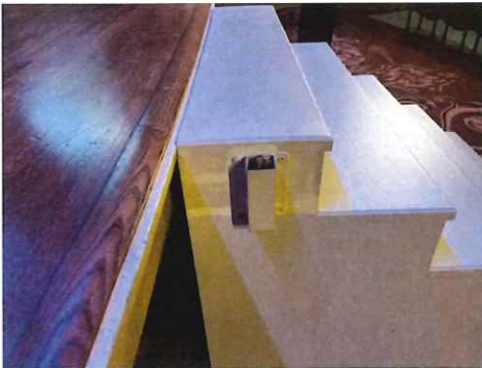
The wood steps added to approach the center stage from the theater floor must have handrails installed as the default condition for code compliance. Handrails, if removed, should be stored on the stage in the wings, taking care to ensure that electrical areas are kept clear.

Handrails should be in place at all times.

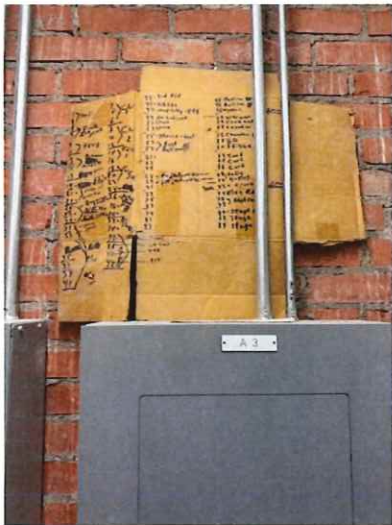
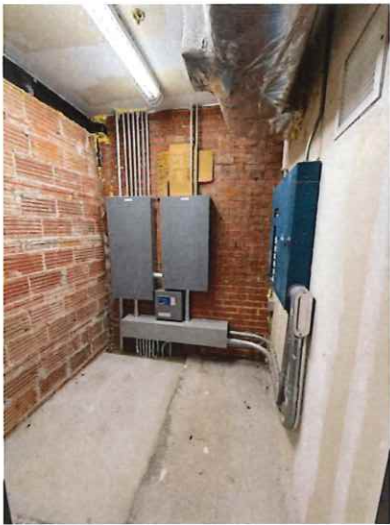
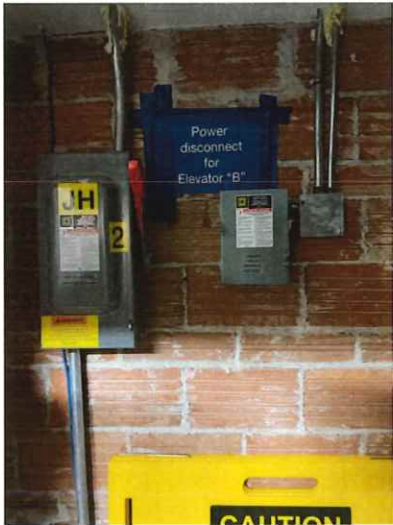
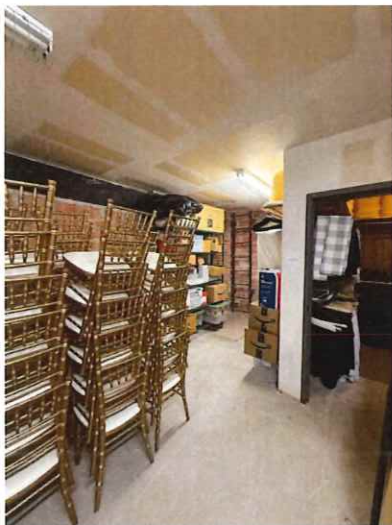
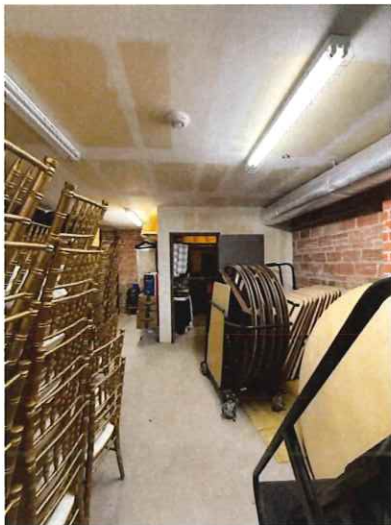
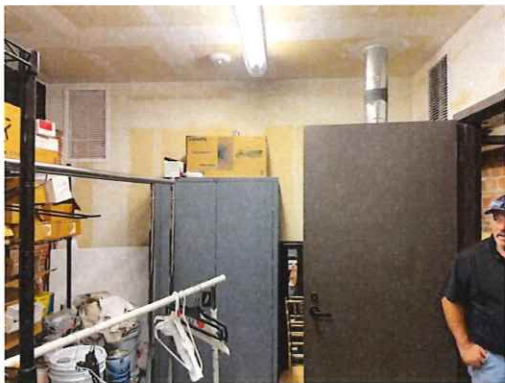
Electrical Panel boxes on the 3<sup>rd</sup> floor do not have circuits marked appropriately. A cardboard legend is leaned up against the wall and tucked behind a conduit. This list should be typed, of legible font size, and placed in a sleeve to be posted on the inside of the panel box door.

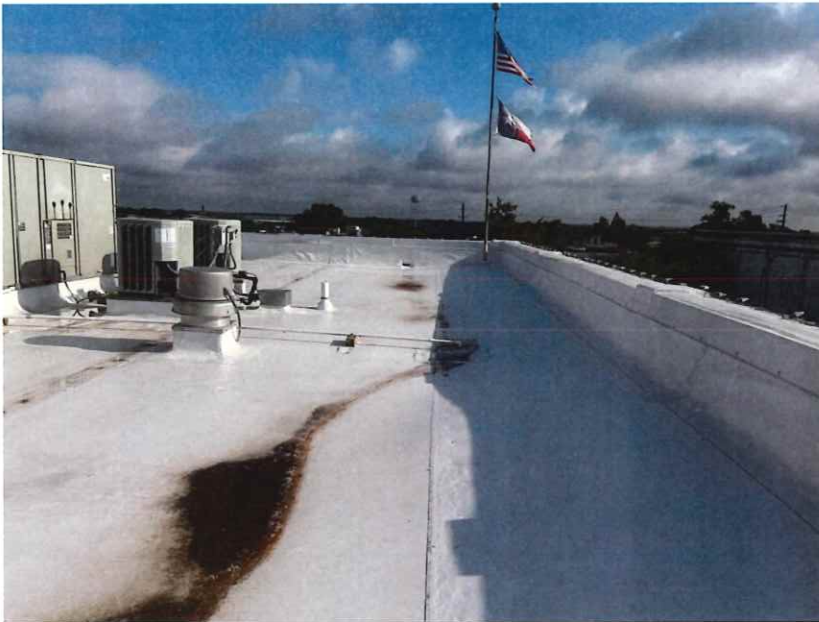
Roof at Theater Building

- Roofing material over the theater building is generally clean.
  - The clay coping cap is in good shape where present. The coping should be replaced at those areas that don't have a cap when the Urns are re-installed.

- Sewer vents were noted to be missing vented pipe caps. The caps serve to ensure that stormwater is not introduced into the sewer system. The caps should be replaced.

- **These roofs are all under warranty. Any repairs should be made through the installaon contractor.**
- Regular roof maintenance should include cleaning and inspecting seams in the TPO.

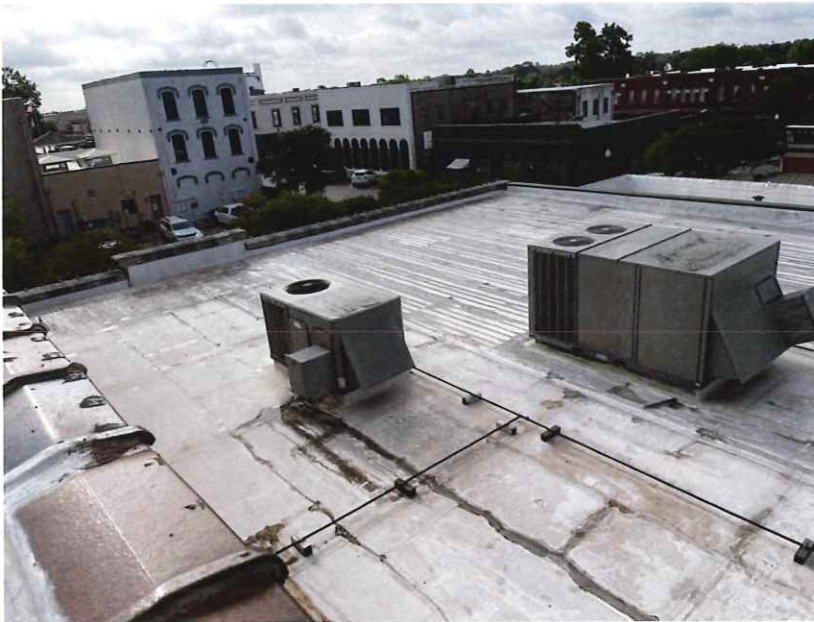
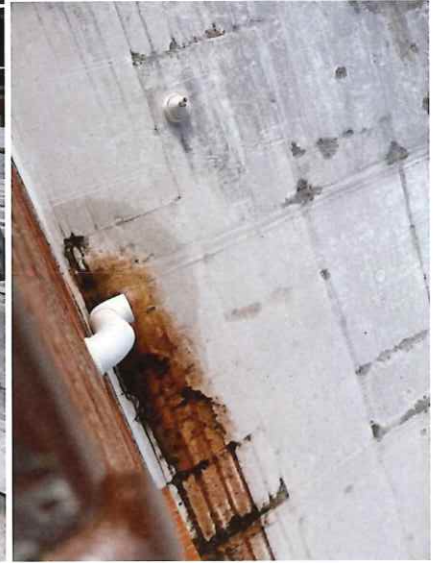
Roof at Morriss Hall

- Roof over Morriss Hall is discolored due to condensate water draining on the roof. Piping for condensate should be re-connected to the HVAC units and drained to scuppers.

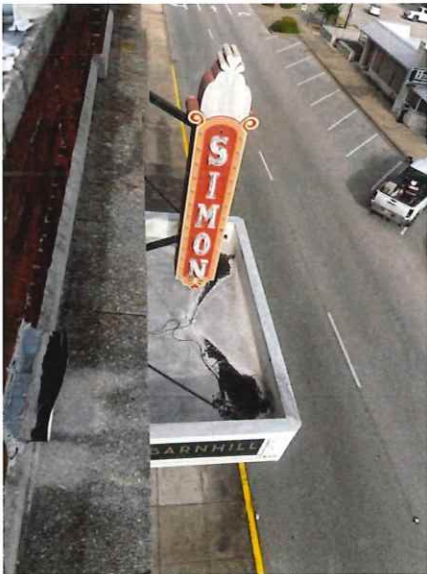
- Sign in general need of refurbishments. Lightbulbs are a mix of LED and incandescent. We were advised LED bulbs are added as the incandescent lamps burn out.
- Metal sign blade requires repainting to restore chipped and peeling paint.

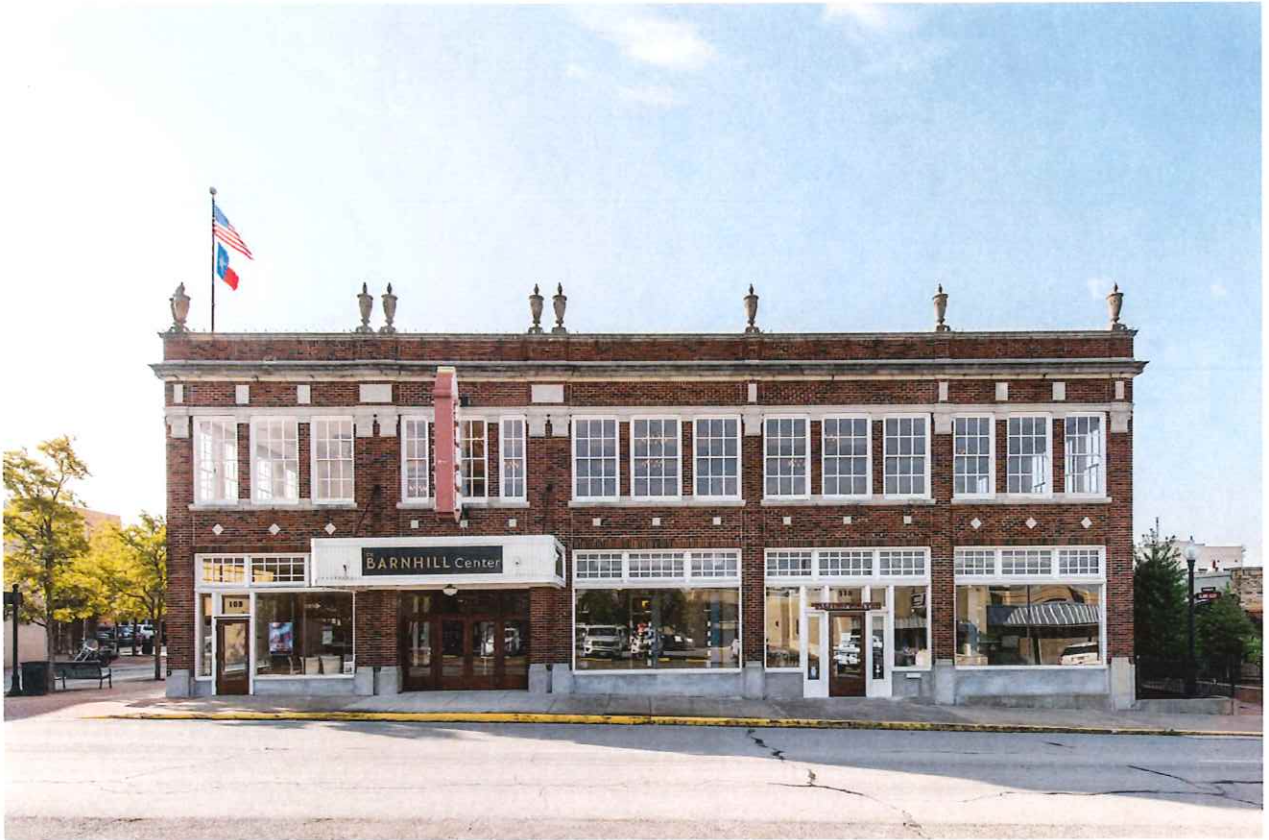
- Decorative urns were removed from the parapet to preserve and stabilize them. Roof penetrations were capped. Urns should be repaired / replaced and re-installed to restore the decorated exterior of the building.

Archival photo of building with Urns in place.

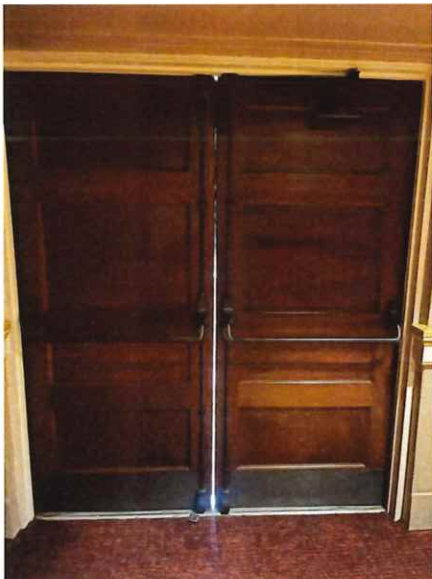
Weatherstripping to be replaced.

- Detailed operations of all doors and hardware were not included in this scope and report. **Review all exterior doors for proper operations. Adjust door hardware and replace weatherstripping as required.**

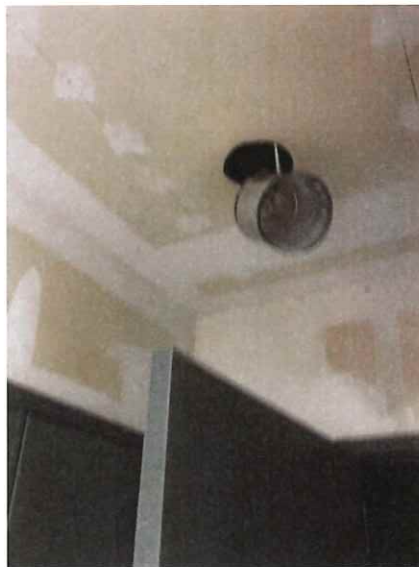
Fixture to be replaced at 3<sup>rd</sup> floor.

- Replace fixture at 3<sup>rd</sup> floor corridor.
- HVAC
  - Systems are reported to be working. Visitors Center reported conditioned air is humid and takes a while to catch up in the mornings. Associated HVAC has been serviced since 6.28.26. Staff to monitor thermostat.

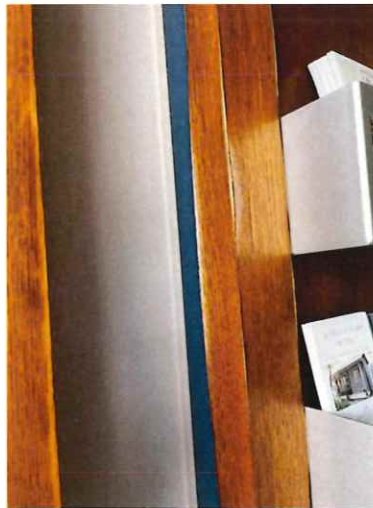
Millwork veneer is delaminating.

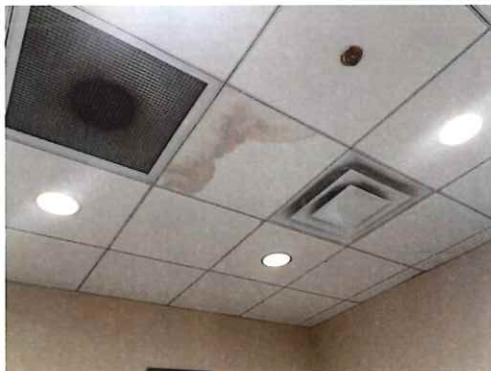
Replace ceiling tiles at water damage.

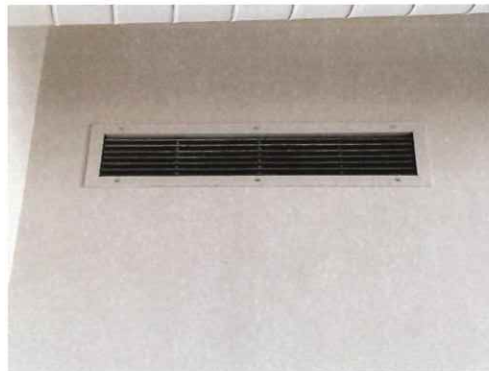
Clean registers. Ensure filters are changed.

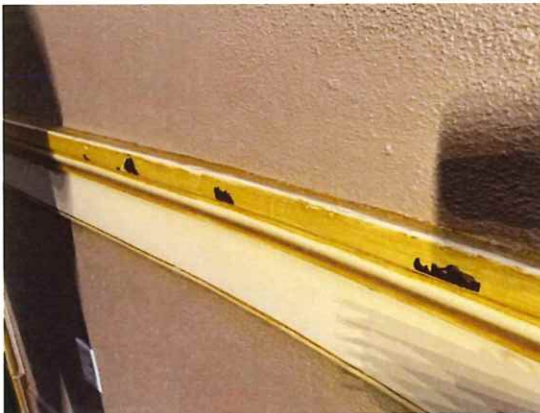
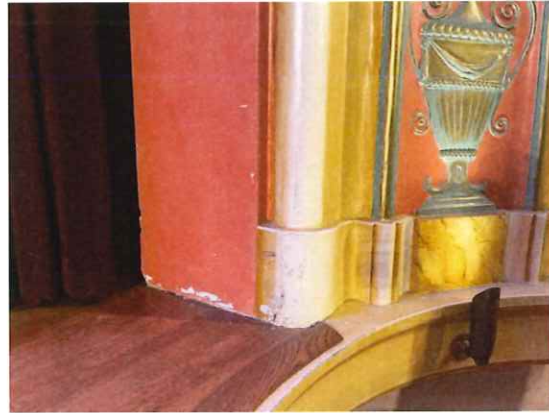
- Theater Office
  - No issues were reported.
- Theater
  - Paint finishes at interior millwork are chipping close to the stage. This can be repaired. Rental agreements should include a prohibition of taping or attaching materials to these historic, and expensive, finishes.
  - Balcony
    - Egress door to the fire escape, which is no longer in use, is not well sealed. The weatherstripping should be replaced.
    - Water leak at the southeast corner of the Balcony is reflecting through the plaster and should be repaired. Plaster and paint are bubbled.
  - Transition strip at the doors between the theater Lobby and the Morriss Hall Lobby is loose and should be re-glued to the floor.

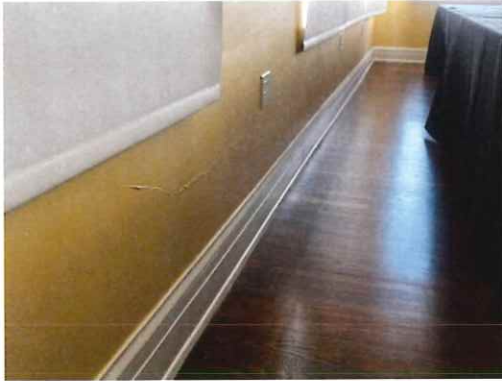
Bullock Ballroom wall damage at west wall.

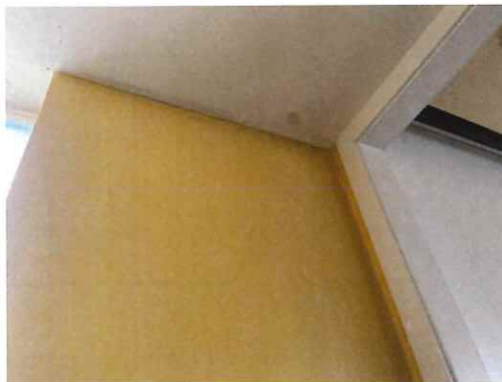
Ceiling damage, requires repainting.
