**NEPA Environmental Assessment
Brenham Family Park
Brenham, Washington County, Texas**

**Prepared for:
City of Brenham
Brenham, Texas**

**Prepared by:
Wild Associates LLC**

Wild Associates Project Number 21.01.016

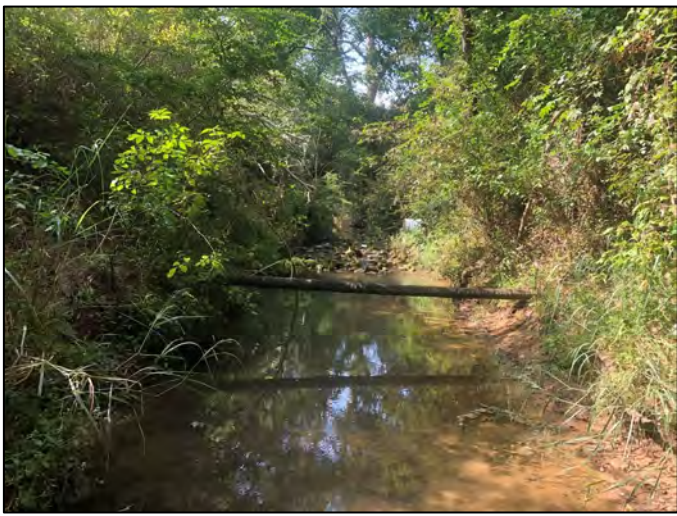
Photo 13: Upstream-facing of gas pipeline.

With respect to potential contamination issues related to the drum, storage tanks, truck frame, and gas pipeline, the drum is filled with sediment; the tanks are corroded and empty; the truck frame has no fuel or maintenance fluids, and the pipeline is under the control of the operator with no evidence of leaks. The City indicated in a letter (Appendix F) that the Site has been agricultural for over a century; the debris is likely washdown from many years ago; and the debris are inert and therefore non-hazardous. An adjacent neighbor indicated there have been no environmental issues at the Site, and the City has no knowledge of contamination on the Site. From discussions with the City, the City has no funds or plans for development in the creek and has taken the position that no work is necessary in the creek to address the inert debris. The EA report was provided to the Texas Commission on Environmental Quality (TCEQ) for comments regarding the potential for contamination related to these features; TCEQ responded in a March 27, 2023 that it did not “...see anything that would suggest a release of contaminants from the debris in the creek.” See Appendix F for TCEQ’s correspondence.

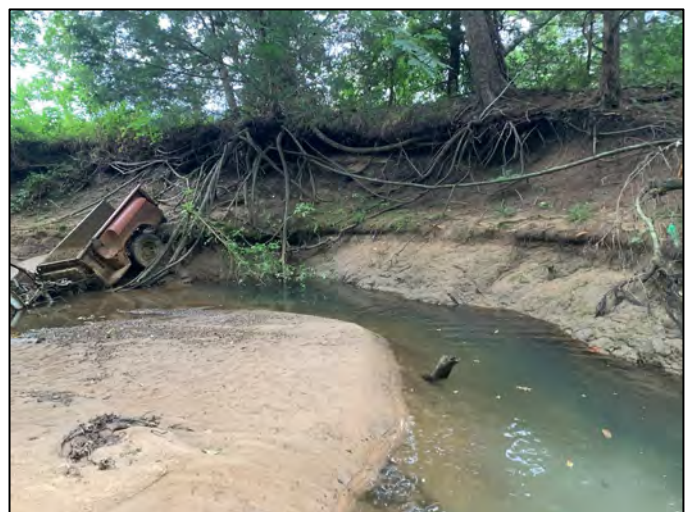
Photo 24: Upstream-facing view of truck and surrounding conditions.

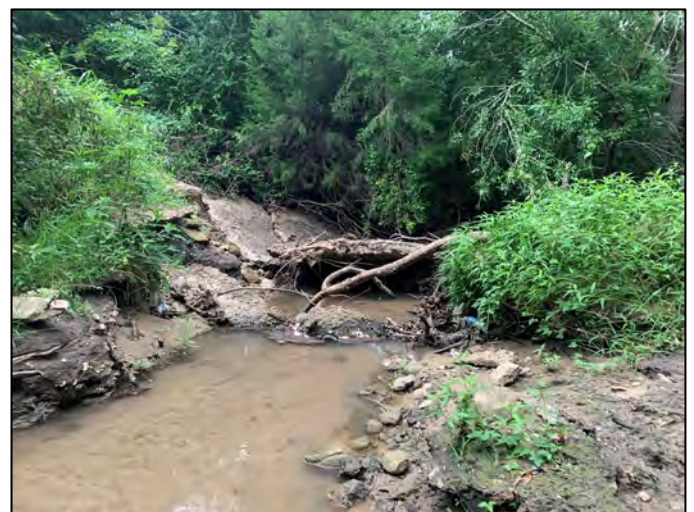
Photo 30: Downstream-facing view of creek and collapsed road.

The creek bottom is mostly very loose sands and silty sands, but in more quiescent stretches, such as just upstream of the culvert at the Site's southern-most boundary, the bottom is soft and mucky with more clay and decaying vegetation; sulfur-smelling "swamp gas" bubbles are common in such stretches. In a few locations, a hard bottom clay is exposed, and rip rap and rock exist sporadically in the upper reach of the creek from the City's storm water culvert discharge pipe northward. Sandier soils were primarily observed exposed along the banks, with more clayey soils observed in smaller stretches, consistent with the Terracon geotechnical report that indicated variability between sands and clays at the depths corresponding to the creek banks. Very loose sand bars and accretions are common within the main flow channel and below the OHWM. Relative to the normal creek high bank widths where erosional cutback has not occurred, there are much larger erosional areas that can exceed 60 ft from high bank to high bank. These erosional areas are strong indicators of the creek's unstable bank regime.

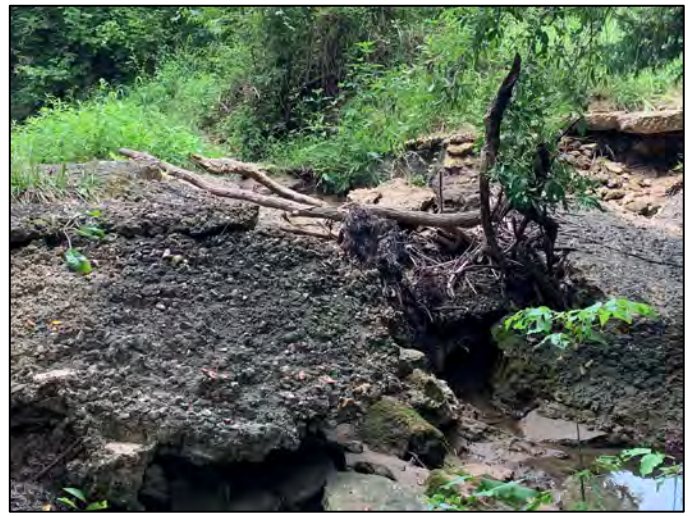
Photo 32: Collapsed road.

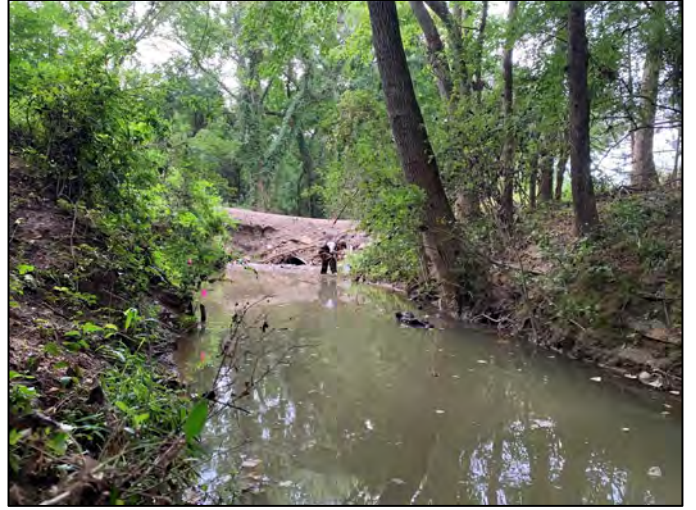
Photo 40: Downstream-facing view of southern dirt road and culvert.

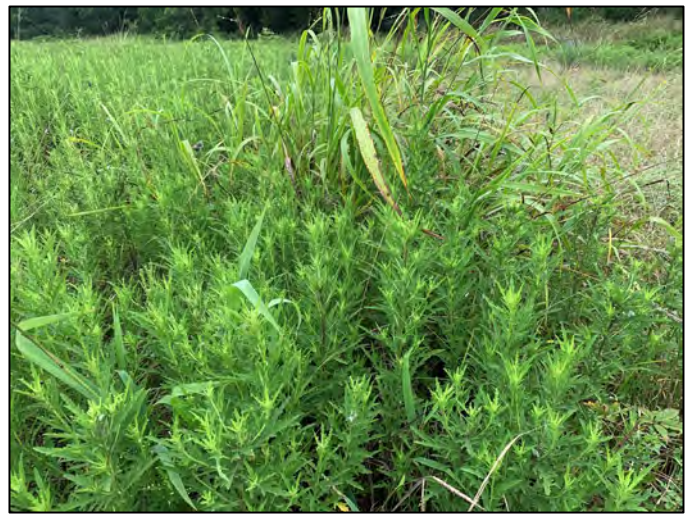
Photo 1: Test Pit 1 non-hydric soil.

Photo 2: Test Pit 1 dominant species Cuman Ragweed (*Ambrosia psilostachya*).

No wetlands were found within the areas scheduled for development or within areas subject to pedestrian traffic. Minimal areas of fringe wetlands along the creek bank toe of slope were found and constituted much less than the 0.10 acre impact limit the USACE cites in their Nationwide Permits program. The fringe wetlands are transitory and of low aquatic resource value because of their high susceptibility to erosional loss due to the unstable bank regime. Data sheets for five test pits (TP-1 to TP-5) documenting evaluation of these three criteria are presented in Appendix M, and photographs of the test pits are presented in Appendix N.

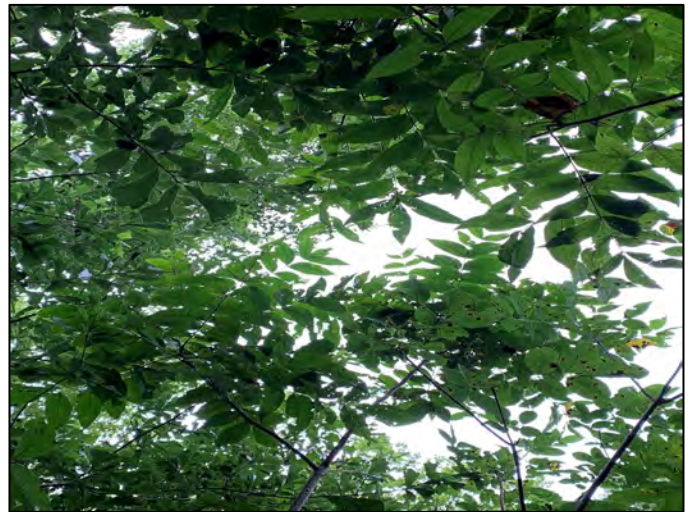
Photo 3: Test Pit 2 non-hydric soil.

Photo 4: Test Pit 2 dominant species Pecan (*Carya illinoensis*).

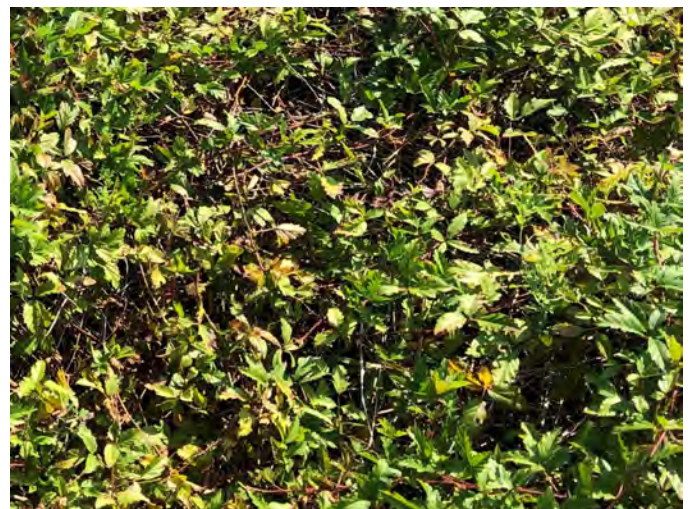
Photo 5: Test Pit 3 non-hydric soil.

Photo 6: Test Pit 3 dominant species Field Blackberry (*Rubus arvensis*).

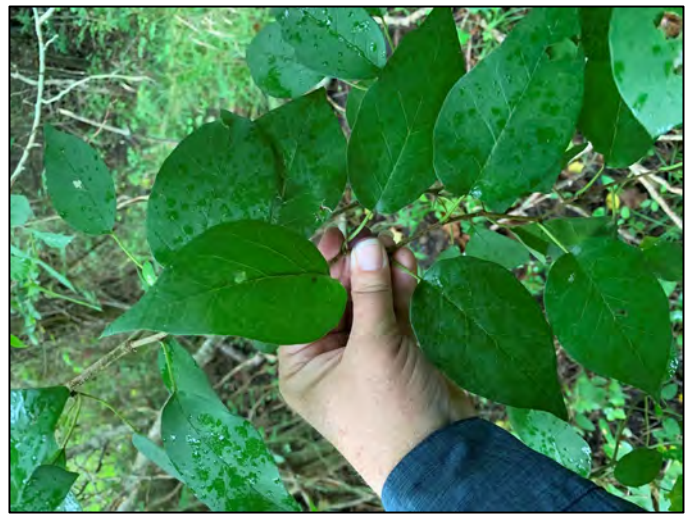
Photo 7: Test Pit 4 non-hydric soil.

Photo 8: Test Pit 4 dominant species Osage-Orange (*Maclura pomifera*).

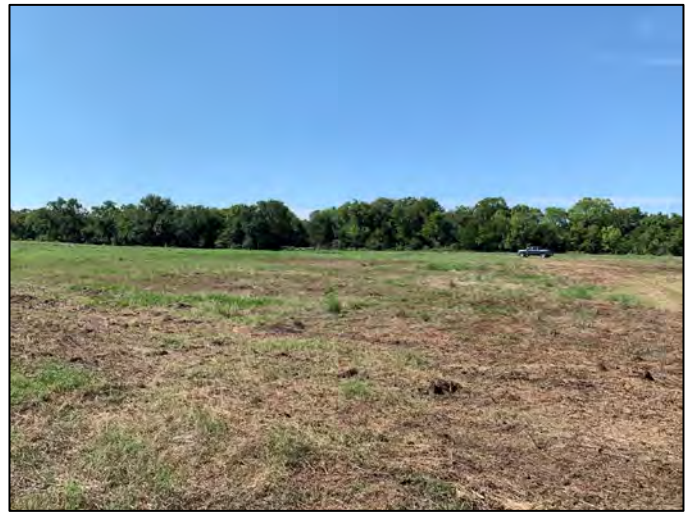
Photo 9: Test Pit 5 non-hydric soil.

Photo 10: Test Pit 5 dominant species Bermuda grass (*Cynodon dactylon*).
